# Implementation of Small Community Owned Water Access Schemes

## Vimbukhalo Village

August 2022

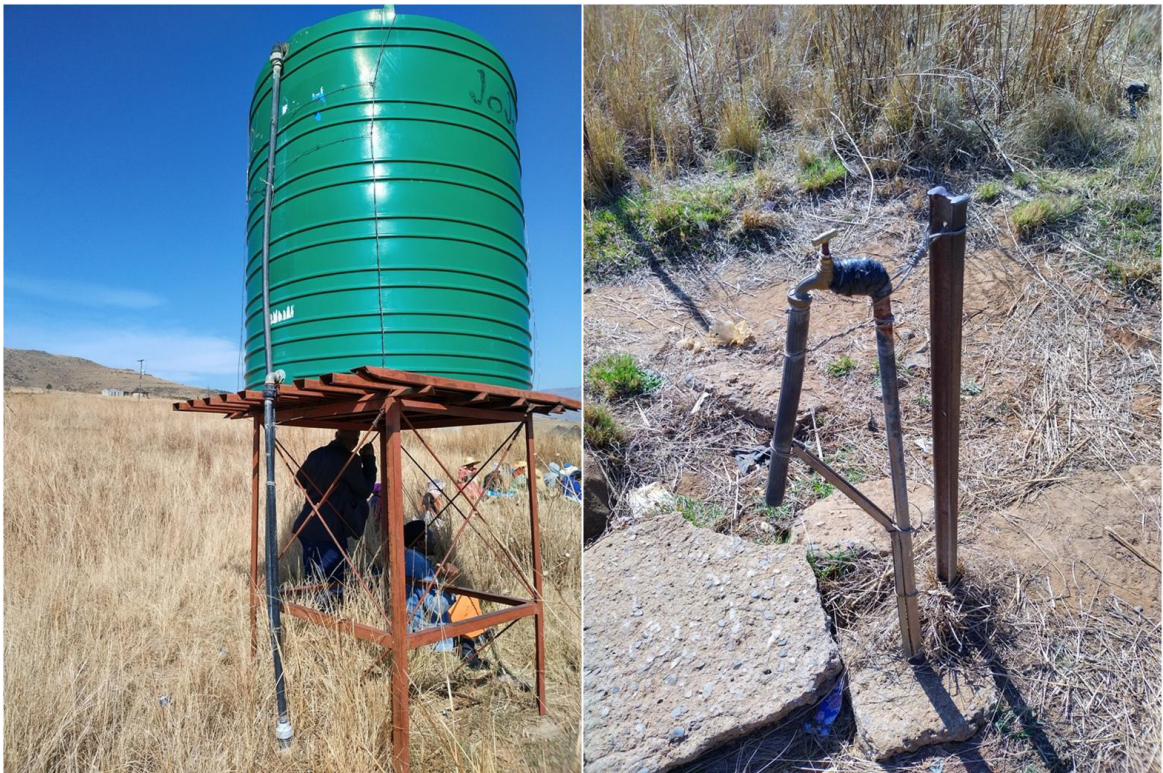
There is an existing borehole equipped with a single phase submersible pump. The borehole pump was donated to the community by Sappi in 2012. The borehole feeds a nearby 5000l tank on a 2m high stand and water is accessed through a single communal standpipe located near the tank. The electrical supply for the borehole is from a private household prepaid connection and the community contributes towards the cost of the electricity usage. There was an electrical issue awhile back and the community tried to repair this, including replacing the electrical cable between the household and the borehole. However, the pump is currently not operational. The community has requested assistance in repairing the borehole equipment and has also expressed interest in reticulating this supply to a few more access points around the village.

*Figs 3 & 4: 5000l water tank and standpipe fed by borehole*

- The community indicated that the borehole used to fill the existing 5000l tank in approximately 4-5 hours. Given this flow it should be possible to provide a second 5000l tank to increase storage and potential to supply further houses in the village. However, this would be guided by the results of the pump test to be conducted.

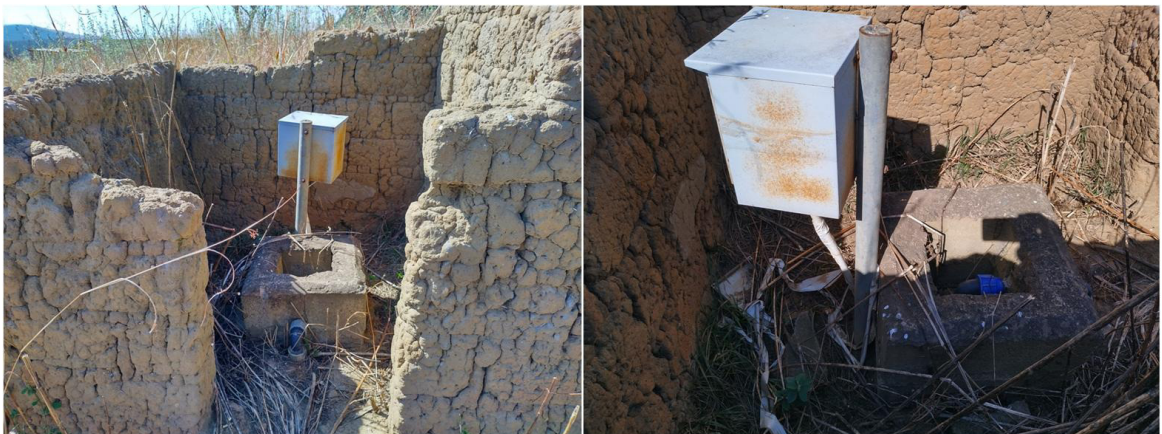
*Figs 5 & 6: Borehole and control box*

- The existing borehole pump will need to be removed and assessed to see if it can still be used or whether a replacement pump will be required. It is recommended to test the yield of the borehole in order to check the suitability of the existing pump, or to guide in sizing a suitable replacement. Water samples can also be taken at the time of yield testing and sent to test for suitability of the water for drinking purposes.

- The electrical works for the borehole need to be redone irrespective of whether the existing pump can be used or whether a new pump is needed. The existing pump control / electrics in the lockable steel enclosure at the borehole is in a bad state and needs to be replaced. The cable installed by the community between the borehole and household with the electrical connection is not the recommended cable type and may not have been suitably sized and the installation not done to standard. Some unsafe and/or incorrect cable joins were noted at the visit. It is recommended to replace this cable with a cable advised by the pump specialist appointed to work on the borehole equipment. The electrical works should also be carried out by a registered electrician / wireman. It would be further proposed to wire the pump connection with its own circuit breaker at the household DB board rather than to plug into a household electrical socket.

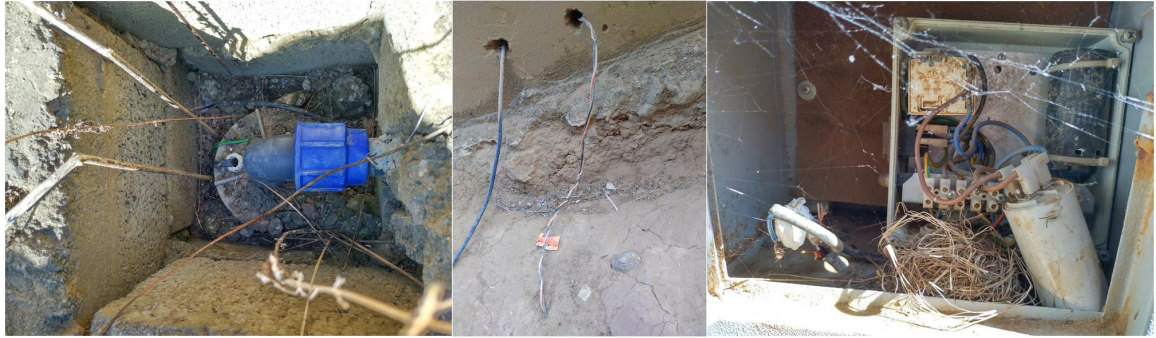
**Figs 7 & 8: Borehole baseplate and state of electrical work**

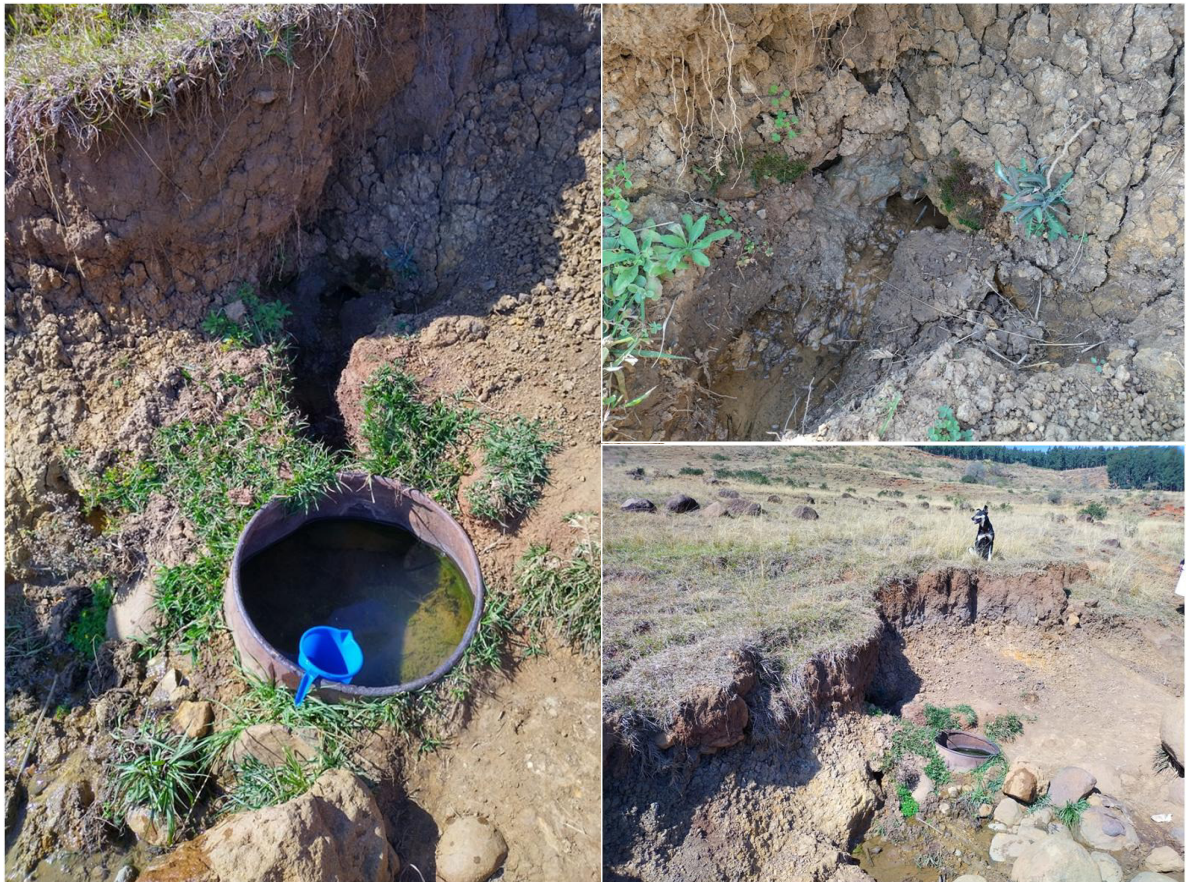
**Figs 9, 10 & 11: Spring1**

The community took the visiting team to a spring situated outside the community area and within Sappi lands, about 300m from the nearest household. This is an undeveloped gravity spring that the nearby households walk up to, to collect water. This spring is perennial although has a low flow in the dry months. At the time of the visit the flow was estimated to be approximately 3 litres per minute. The community requested assistance in developing the spring and piping water closer to the village. Any work conducted at this spring would need to involve discussions with Sappi in order to obtain approval to do so. It would also be advisable to check whether the land directly around the spring is intended to be used for plantations as this could impact the availability of water in the future.

If required this spring could be protected and water piped to a storage tank in the village. The current flow from the spring (dry season) was estimated to be low at only 2-3 l/min. This would be sufficient to fill a 2500l tank overnight and could serve some of the higher lying households above the borehole position. Households at the top of the hill would, however, still need to walk down to the water access point at the tank. Development of this spring and running a pipeline to the village would involve discussions with Sappi as the spring lies on their land.

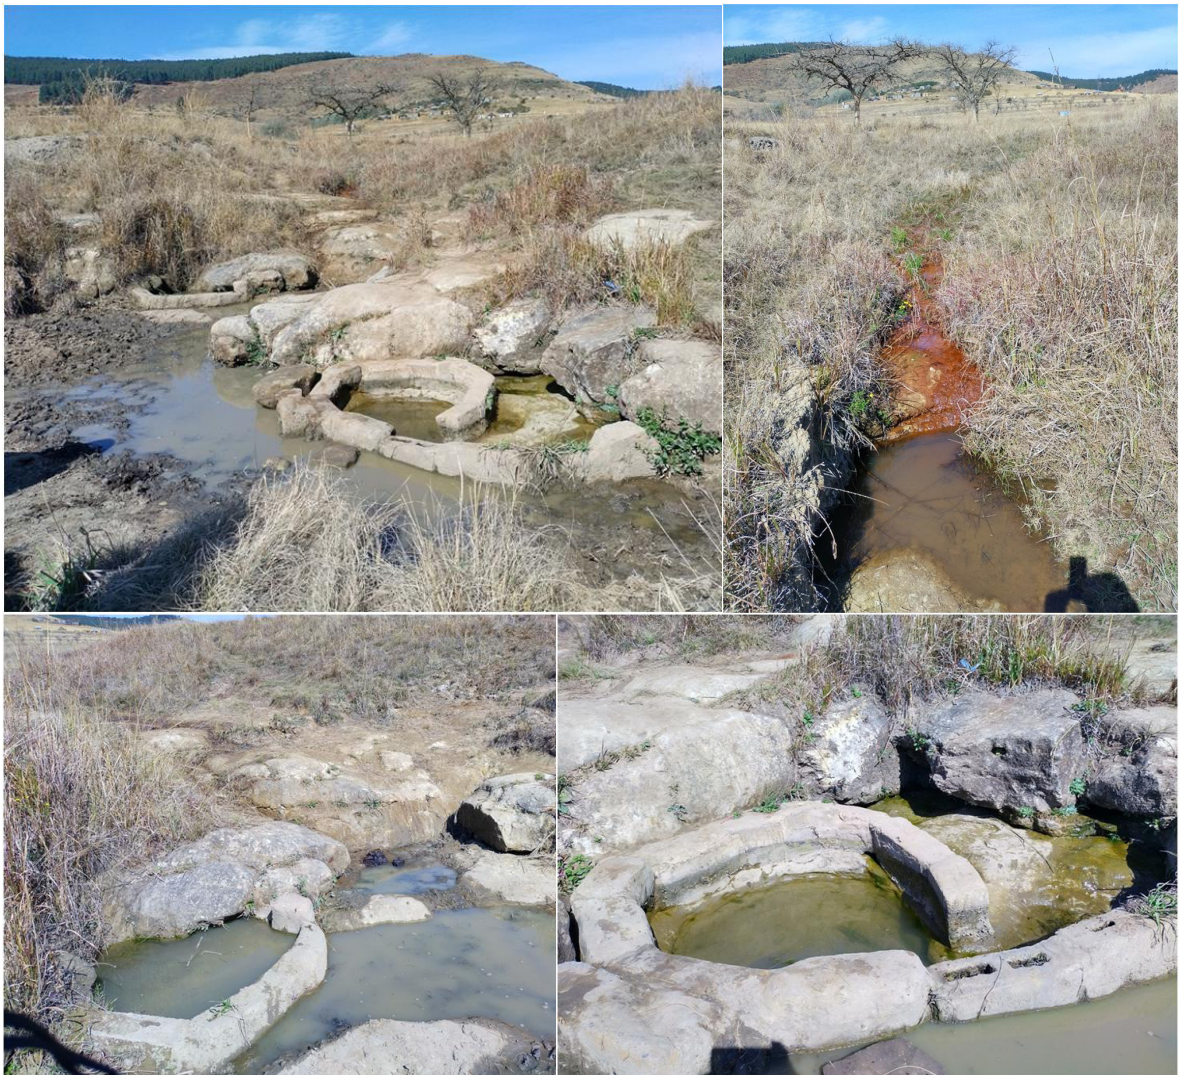
*Figs 12, 13, 14 & 15: "Spring2"*

A second "spring" location was also shown by the community. This comprised two small collection points built by the community using concrete blocks around two small "seeps" within a natural drainage channel / watercourse. Flow appears very low and it is not apparent whether the water at these two collection points are definitely from "springs" or whether from the surface water in the channel working its way through the rock at that point.

At the time of the site visit no further investigation was conducted higher up towards the head of the channel. This area also appears to be heavily trafficked by livestock making it difficult to collect uncontaminated water. It is not recommended to undertake any development of this water source.

No work is proposed to be undertaken at this source.

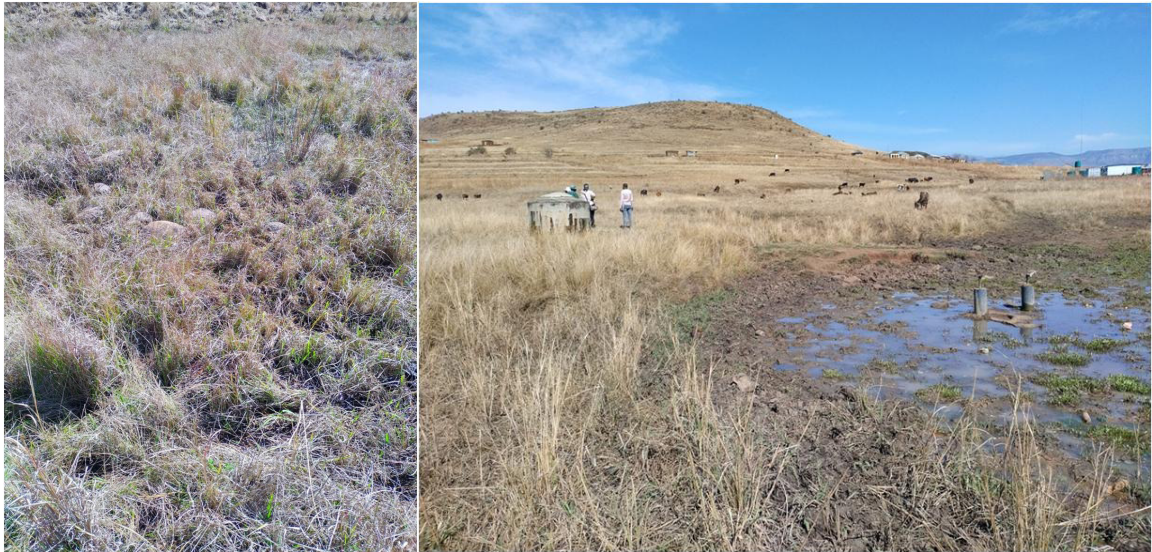
A third spring viewed is an existing system developed many years ago. This spring feeds an old concrete tank that supplies two standpipes near the tank. Water leaks and a fairly flat terrain have resulted in ponding of water around the standpipes, making them difficult to access. Some repair work to the concrete tank is also required as it is leaking through the sides of the structure. The spring source was not evident but its position was pointed out by the community. No water or physical structure (other than some rocks) could be seen as these lie

under grassland, but the system is functioning and water is available at the tank and standpipes. There is no fencing around the spring source.

*Figs 16 & 17: Spring3 source and tank and standpipes*

The source and development of this supply is below ground so the condition of any collection structure here is unknown. However, water is flowing through to the old storage tank so no work is proposed to be undertaken at this source. Fencing could be added in this area to limit possible contamination of the water by livestock.

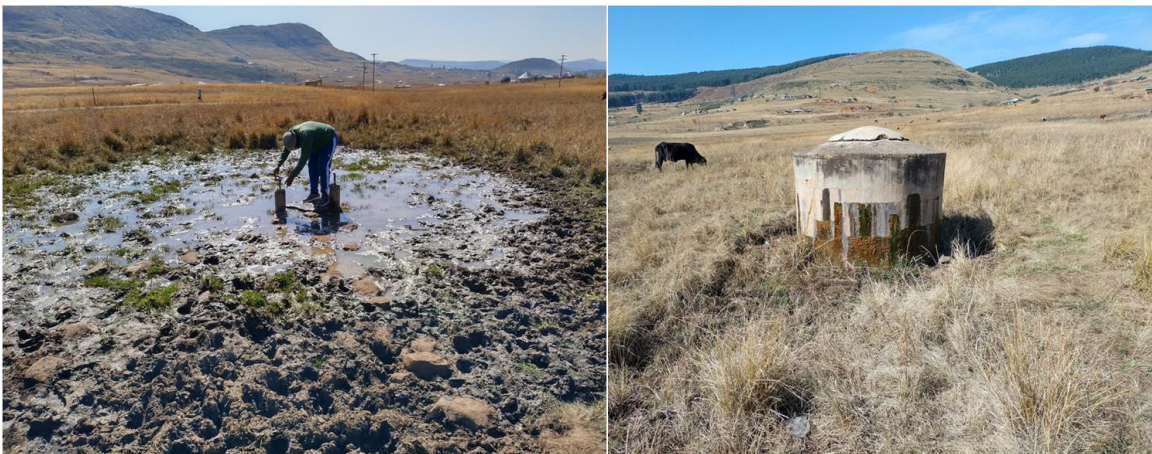
*Figs 18 & 19: Standpipes and concrete tank*

The concrete tank is leaking and would need some repair work. It is proposed to open the roof access, drain the tank, and then further inspect and line the interior of the tank with a membrane and waterproofing product.

A concrete walkway to provide easier access to the standpipes could be constructed. Local rock could be collected by the community and used as fill to create the base of the walkway that would then be topped with a concrete slab. The community could also look to open up the channel to allow drainage of the standing water along the existing natural drainage channel.
