Ezibomvini: Water Walk – 2nd October 2024

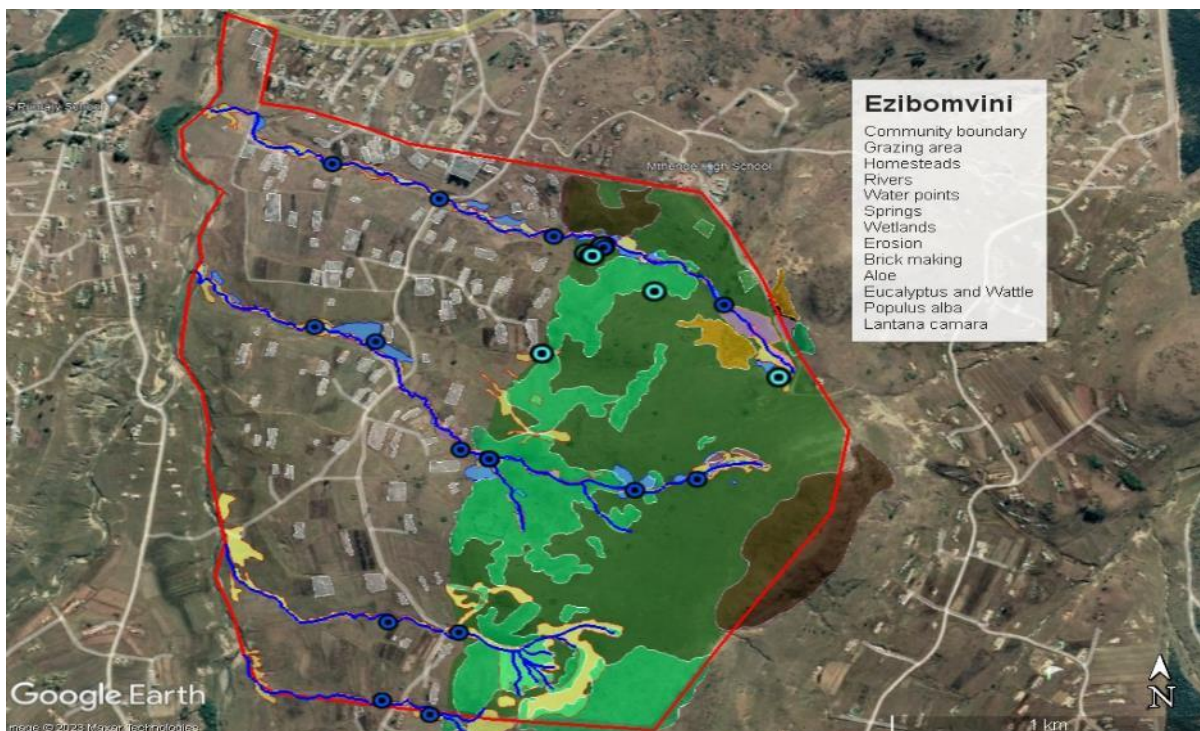
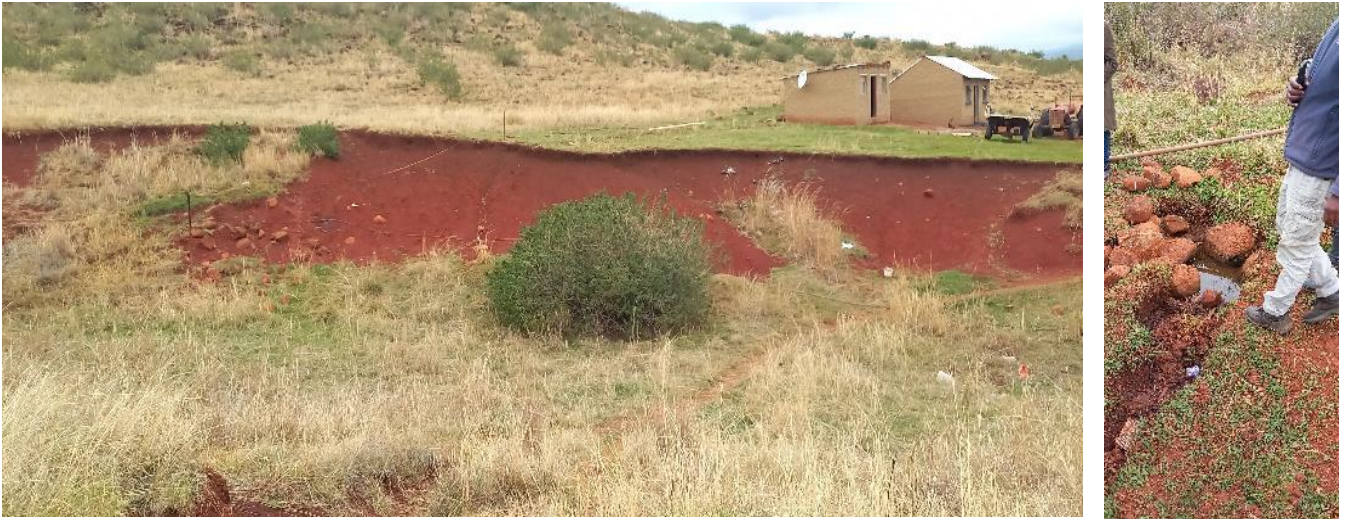
Figure 1: Above Left and Right: A typical donga in the upper part of the catchment – highly erodible red soils and a local spring being used by 2 household for water provision.

The picture above shows the typical process of erosion in mid-slopes of the catchment (where most of the farming occurs and where households are built). These deep red soils are highly erodible and often form deep gulleys, which can be stable at the bottom, where they change into shales. The sides, however, continue to erode. The picture also shows the extent of Lantana camera invasion (all green-grey bushes in this picture). These were cleared by eco-champs in two successive seasons 2021-2023 and were sprayed with herbicide in the second round of clearing. The Lantana has however recovered and re-grown. The small picture on the right, shows a typical small spring in the area – which occur in small wetland patches in and around the upper catchment stream beds.

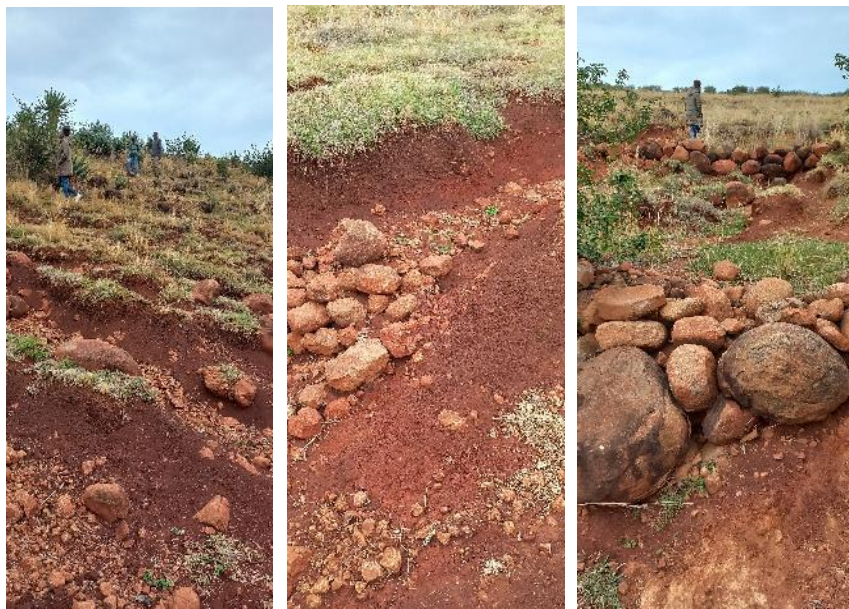
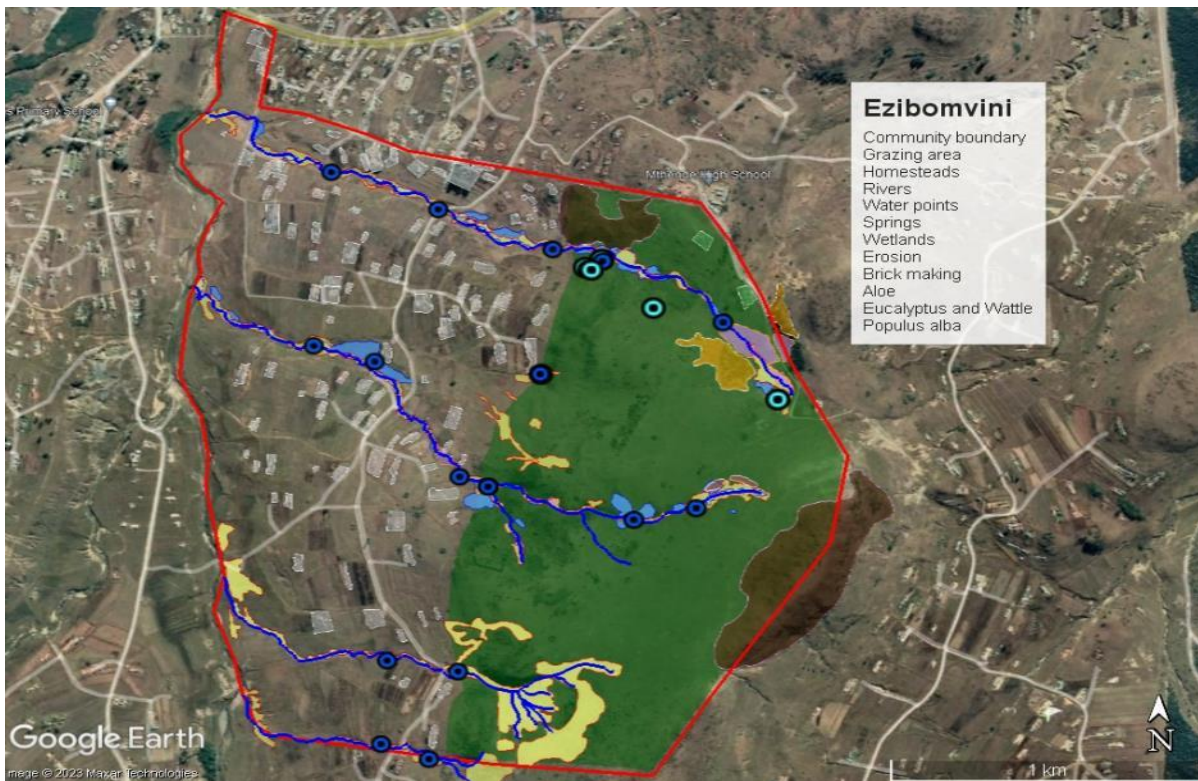
Figure 2:Left: Small gulleys, littered with stones and small rocks form before turning into a larger gully.

Centre: A stone pack in a gully, destroyed by movement of water and cattle.

Right: A stone pack which worked well – sediment behind the stone pack has allowed from growth of grass

- Clearing of lantana in and around the streambeds
 - Continue with check dams and stone lines for small gulleys and cattle paths that feed into these water courses and do diversion ditches (horse shoe shaped) above head cuts (mainly for middle and 3rd streams).

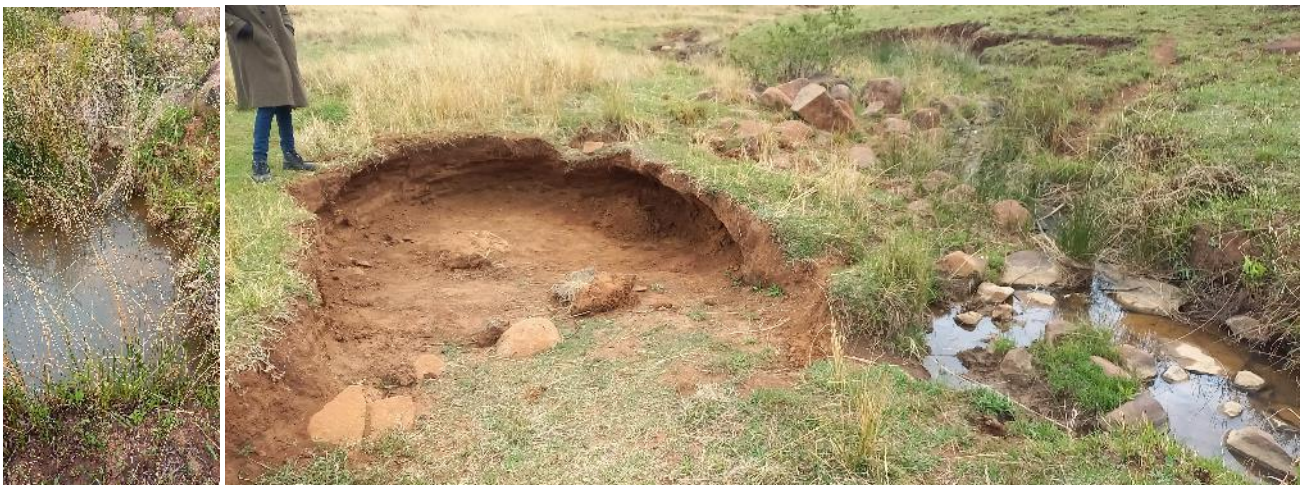
Figure 4: Above Left and Right: a water point and a view of the middle stream. Note the greyish discolouration of the water – a characteristic which has meant the people in the vicinity do not use this water for drinking, believing it to be contaminated.

In this water course the side-bank erosion of the red soils in the middle section of the slope is also very evident, as seen in the two pictures alongside. In steeper sections of the slope the gully is very deep littered with rocks at the bottom and in the gentler sloping area the gully is not that deep and the rocks on the edges provide some stabilisation – leading to an undulating shape for the water course, as the gully widens suddenly in patches where there aren't any rocks.

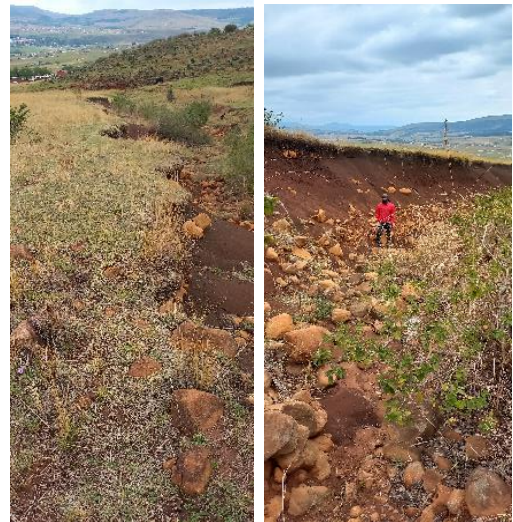
Figure 5: Right: The white block indicates the third stream, the yellow portions indicate erosion, which is much more severe and extensive in and around this watercourse.

The erosion in this section is severe and the gully very deep. It may only be possible to intervene in the areas surrounding this gully to reduce and minimize the inflow of water into this gully.

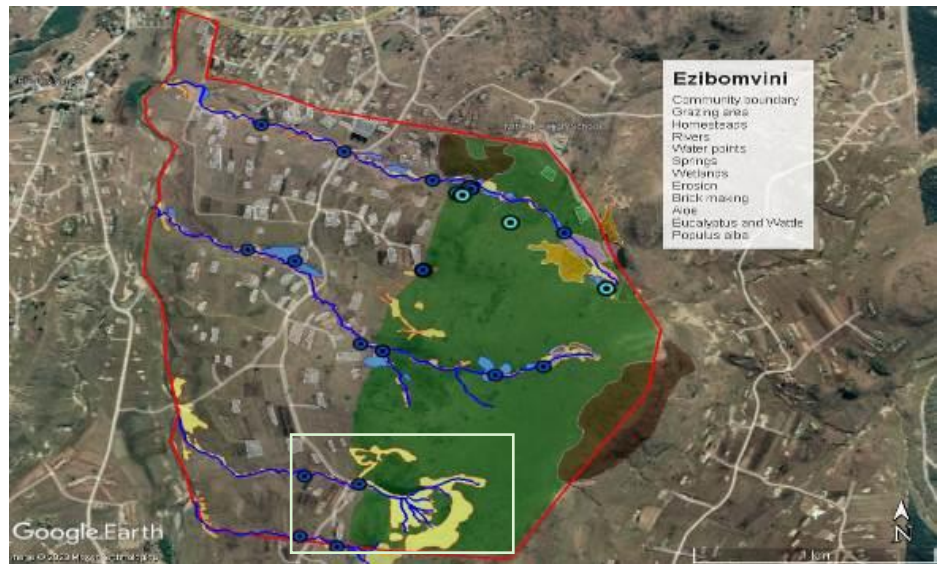
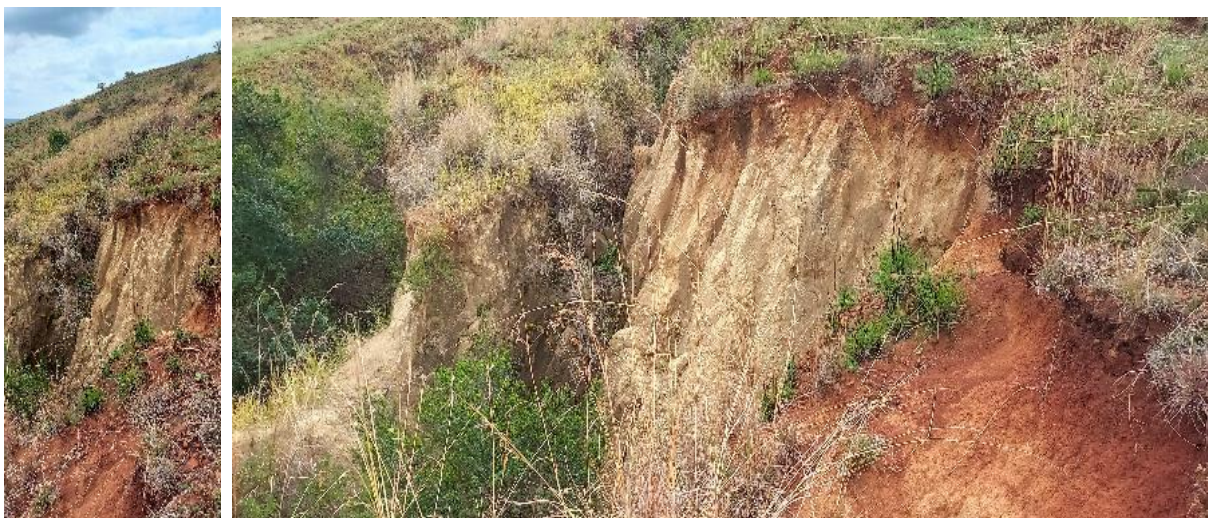
Figure 6: Extensive erosion of the soft white sandstones forming a deep gully close to the third stream watercourse.

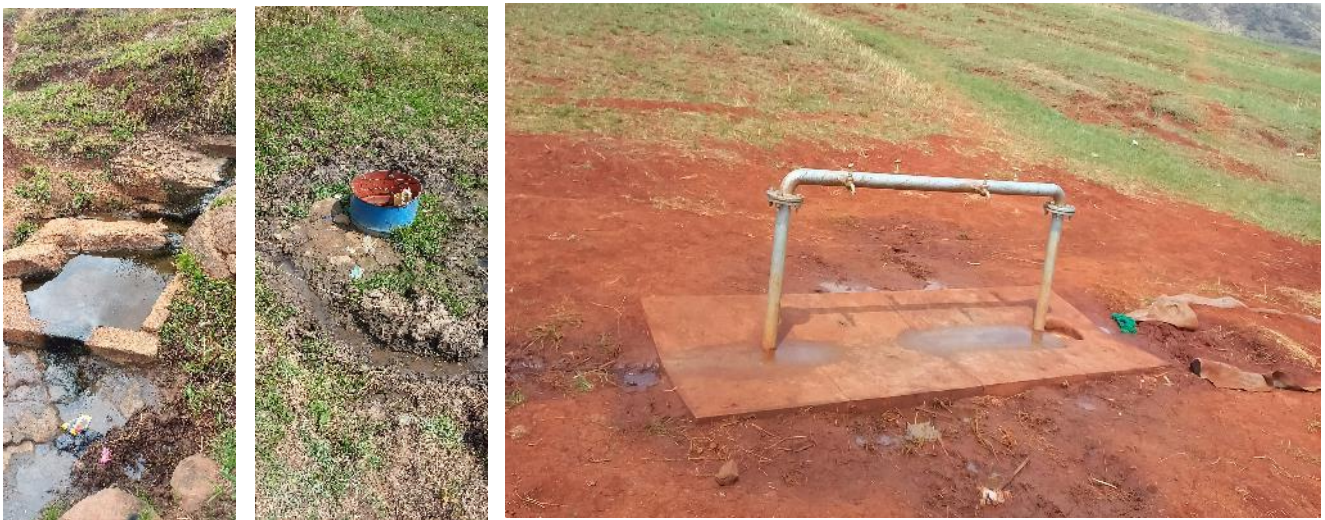
In addition there is a protected spring with a tank, which was installed at least 20 years ago and a very recent borehole reticulated to taps on the side of the road, which was undertaken by the municipality.

Figure 7: Above left to right: Protected springs by local community members and the taps provided by the Municipality for a borehole drilled directly into the wetland.

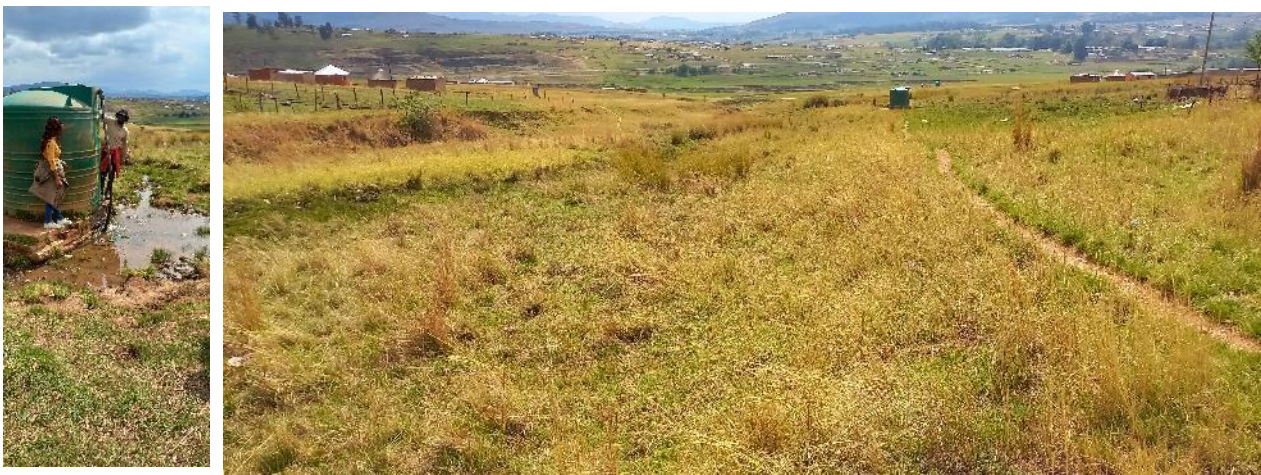
Figure 8: An old spring protection point with a JoJo tank that was installed before 2000. The tank is leaking, and the overflow pipe was removed, creating a small pond in the area where water should be collected. In addition, the tank is on the edge of one of the homesteads on the edge of the wetland and there have been 'ownership' issues both of this water and of the wetland as a result.

- Prioritize 3-4 small springs that are in use: protect by fencing, setting up JoJo tank and cattle drinking points outside fenced areas and do a small v-box if called for at each spring.
