Costone/Stulwane wetland water walk: 3rd October 2024

OUTLINE

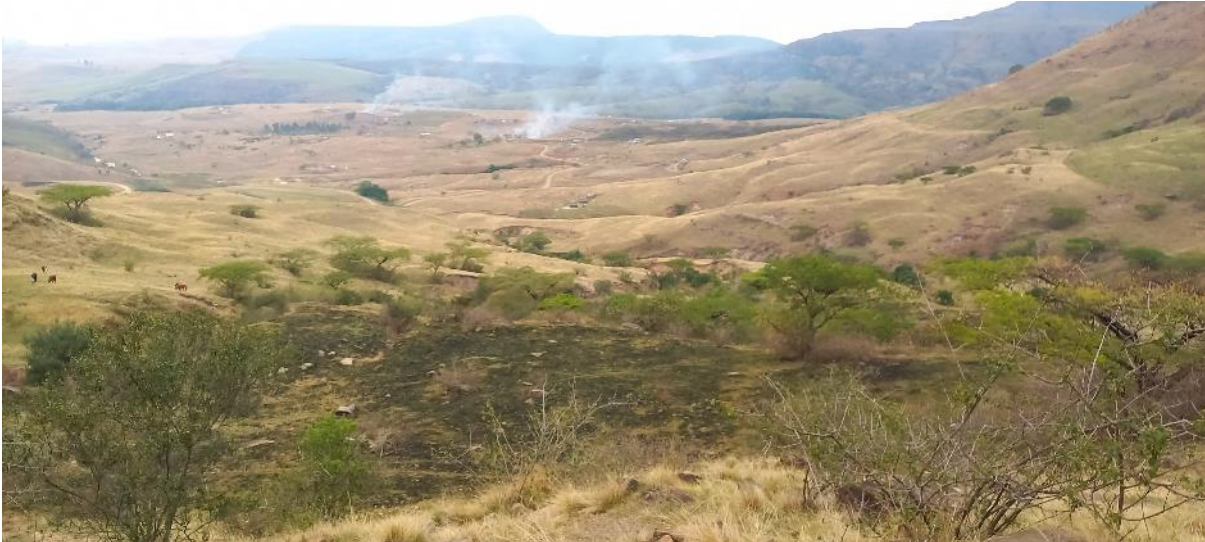
Figure 1: Above: A few from the upper catchment and grazing area of the Costone village looking down into the valley where homesteads are present. In the picture a few small fires are visible – farmers were burning the edges of their fields in preparation for the planting season – a practice which is not promoted by MDF, but which nevertheless persists. As does burning patches of the grazing area itself to allow for quick green growth early in the season. This winter season was the first time that the whole grazing area wasn't burnt, and followed on awareness raising around burning and livestock owners undertaking communal firebreaks for the first time.

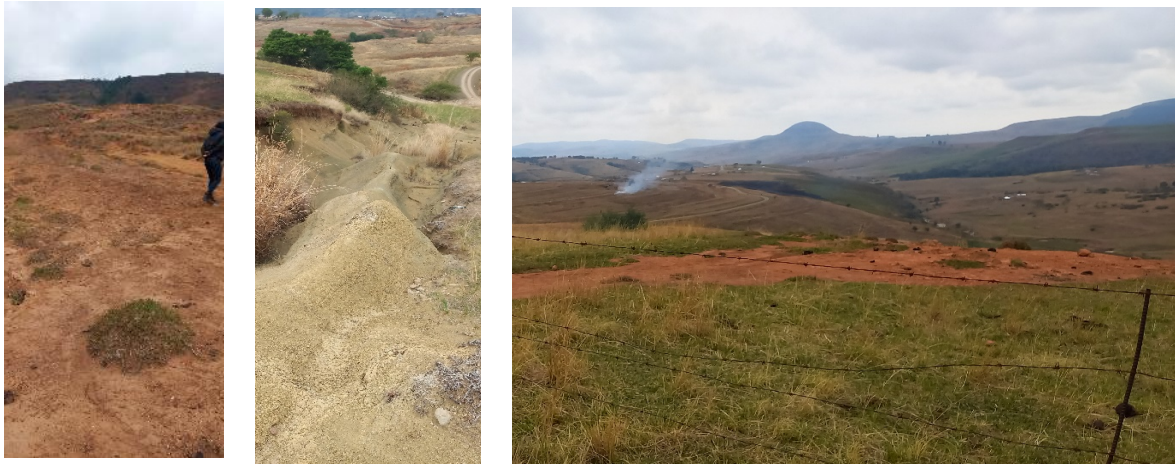
This area is severely eroded due to cattle moving up and down the mountain repeatedly for dipping and for being taken to and from the grazing areas higher up. Typically a path is worn, which erodes and then another path is worn alongside until that too turns into a donga, leading to this type of extensive erosion.

Here, the few stone line and stone packs that were done by the community have had very little impact so far, both because they were not extensive enough, not well keyed into the banks and constructed too far down.

Figure 3: Above Left to Right: Views of the extensive erosion of the ‘cattle paths’ above the road, and past the dip tank. The picture on the right shows the top of the small hill, just beyond the fence where the erosion control works should start.

It was recommended that they start at the top of this small slope, just below the grazing area fence and work more with stone lines that cross the whole area of connected gulleys. And also that the principle of toe-heel structures is used – so 1 m in height difference between structures (3-4 m on the ground), as the present attempts were also made too far apart.

In addition, the participants here used quite large rocks and piled them quite high in a rather haphazard fashion, rather than using the recommended process of keying in the larger rocks into a small ditch on contour and then packing the smaller rocks on top of these with a slope of 1:1 (50%) on the upstream side and an 'apron' on the downstream side or a steeper slope of 1:2 (75%). These recommendations should be more closely followed in the future.

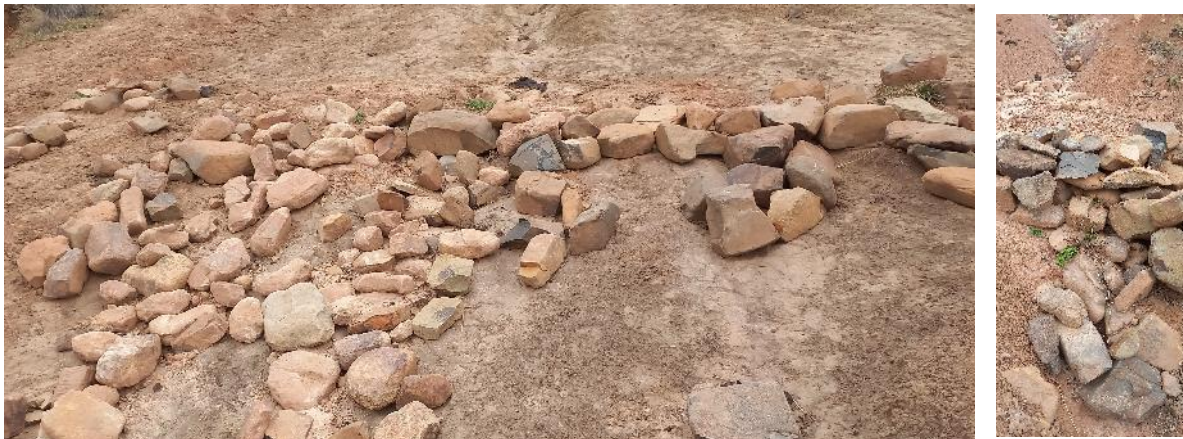
Figure 4: Above Left: A stone line on the slope which has been destroyed by livestock movement and Right: A check dam which has been damaged by strong water flow, but which still managed to collect a reasonable amount of silt upstream of the structure.

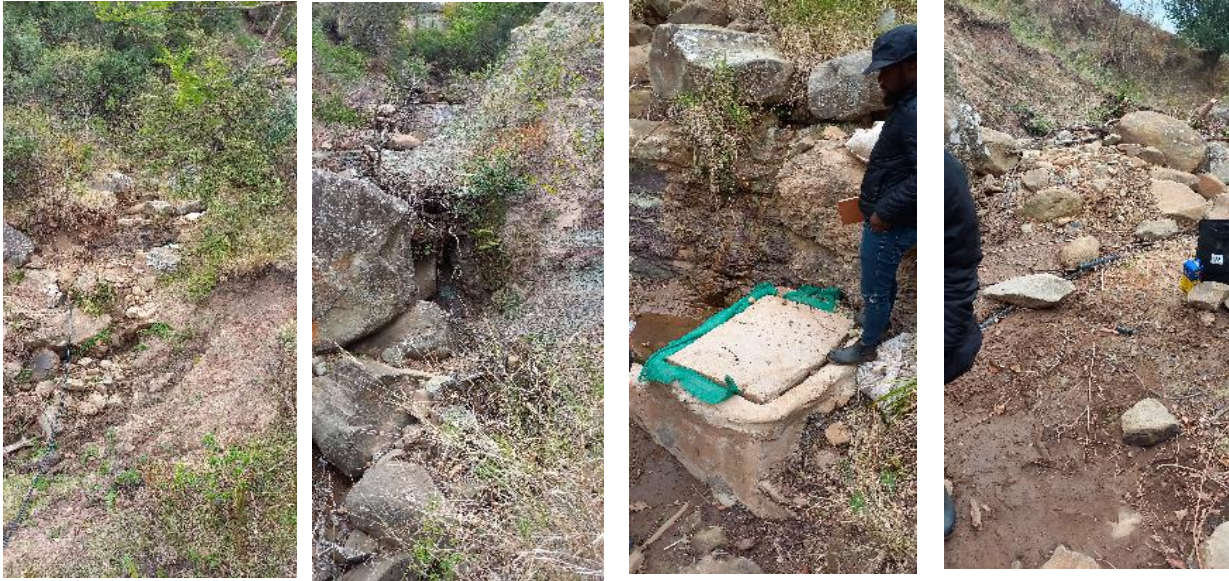
The small water course is presently dry below the abstraction point as the tiny trickle of water presently available is going directly into the collection chamber. This is likely to change once the rains start. There was a period in August-September that the flow was even lower than at present. In this time Nothile Zondi followed the recommendation to close the valves below the main JoJo tank to allow the tanks to slowly fill up and only open them for a brief period for water collection around 8am and 4pm in the afternoon. This process worked quite well to allow all participants to get some water, albeit not very much. The process however was only followed once the tanks started to run dry, before which participants collected water at will.

The design of the pipes and tanks, as well as the abstraction point is such that when the stream is flowing, not more than 10-15% of the flow is used for the water scheme. There is a concern about capturing most of the flow in the very dry months towards the end of winter – noting that this stream is by nature ephemeral and doesn’t flow throughout the year. However, it is recommended that the situation is monitored in an ongoing way to ensure that the removal of water from this water course doesn’t have a negative impact on the surrounding environment.

Figure 5: Above Left to Right: 1. A view of the stream bed below the abstraction point and 2. A view of the stream bed above the abstraction point. 3. A view of the collection and settling chamber at the abstraction point. And 4. A view of the 'small pond' – now dry, directly below the collection chamber.

This stream bed is steep and quite rocky and little rehabilitation is possible in the stream bed itself. As is the case in Ezibomvini, but more pronounced and with the yellower clay soils, the side walls of the water course have eroded quite severely in some sections and is still somewhat stable in others.

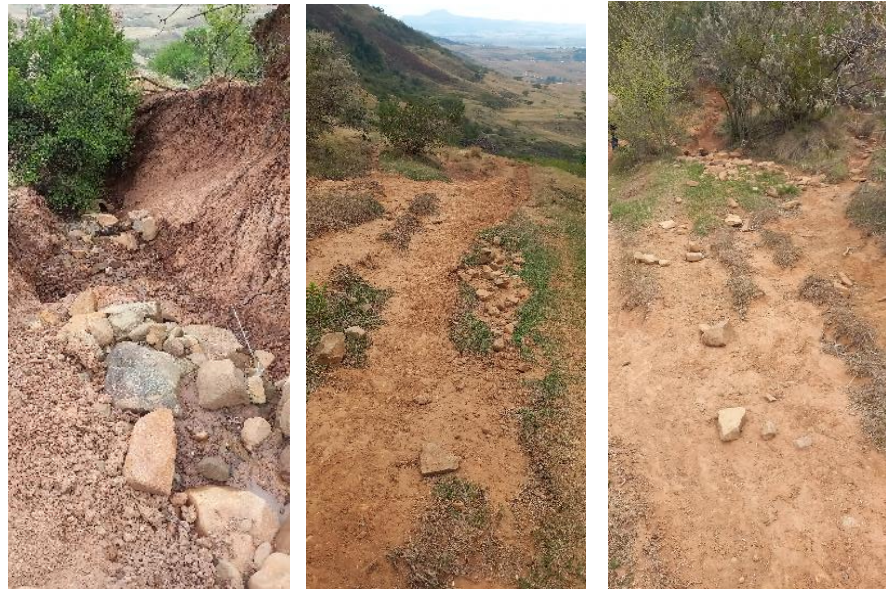
The area surrounding this stream doesn't have any noticeable wetland patches, but a lot of erosion in the area is evident, as cattle move in and out of all the small water courses at multiple points to look for water.

Figure 6: Left to Right: A gully with unstable side walls, exacerbated by livestock coming into the water course to find water. Two views of paths between the small water courses made by cattle and being eroded into gulleys.

- Build specific cattle watering points. And channel the livestock there by plugging some of the myriads of small paths and gulleys the livestock use.
- Then build ‘steps’ along these paths to stabilise them and for ease of movement for the livestock.

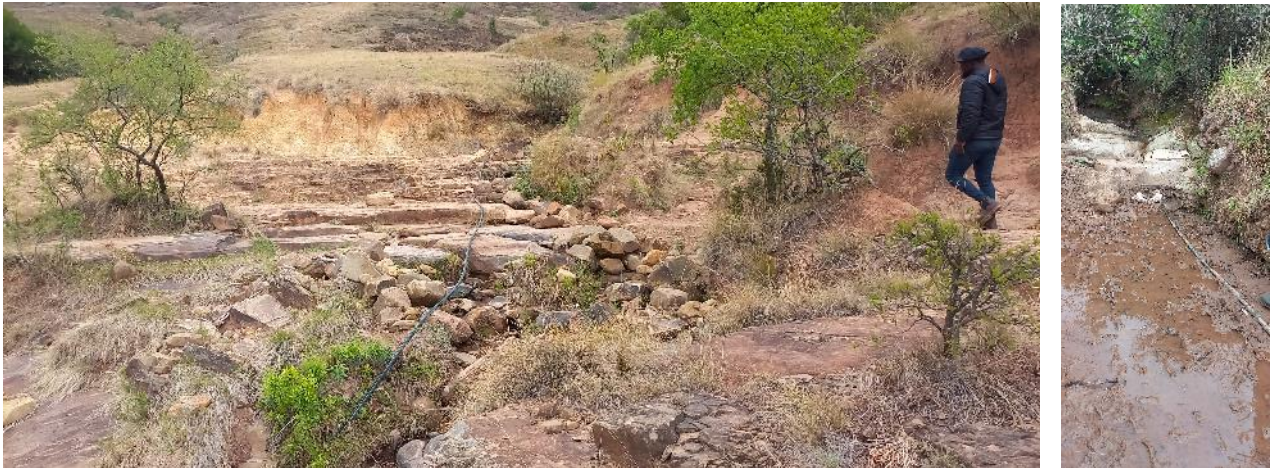
For this side of the village, the abstraction point was moved by the community from the built collection chamber to another small stream for the winter months, given that there appears to be slightly more water there.

Figure 7: Above Left: The water course just below the 2nd abstraction point, for Section B of the community. Right: the small collection and settling chambers visible in the streambed.

- Linked to that is protecting the small pools of the abstraction points from livestock trampling.
- Side walls will need a similar set of strategies as in Ezibomvini – try these out in Ezibomvini first and then apply the ones that work best in the Stulwane upper catchment (check dams, brush packs, netting mats, diversion ditches, planting of vegetation and fencing)

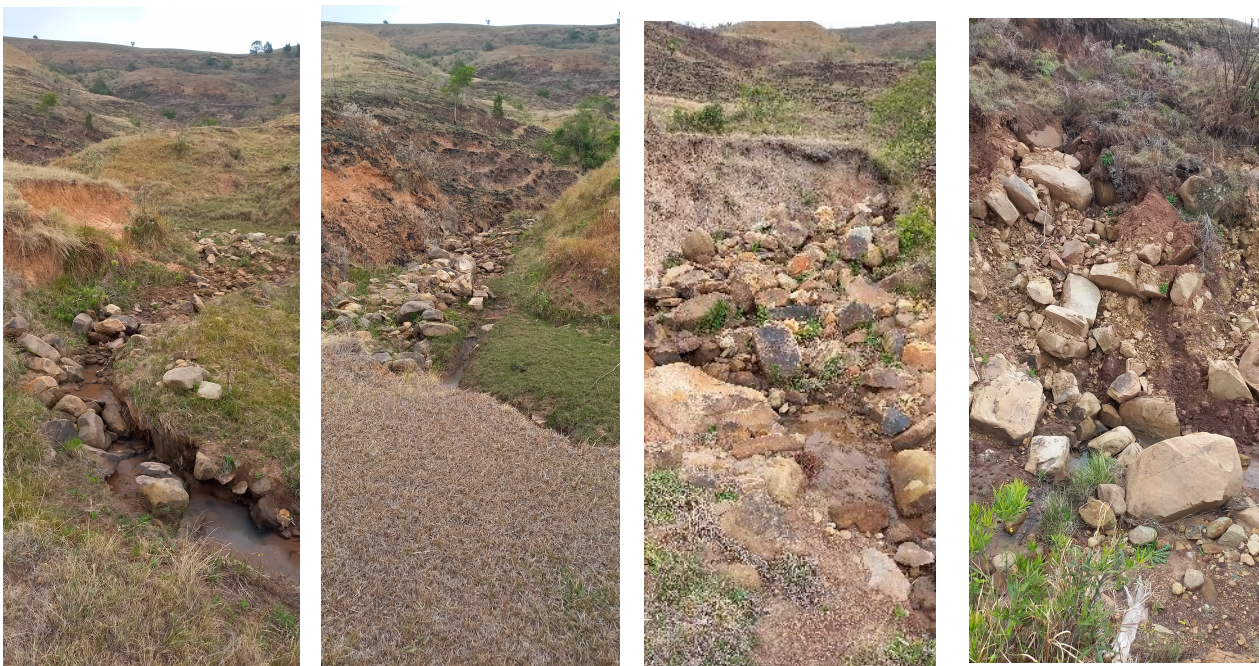
The condition of the water course above the abstraction point is deteriorating. There are small wetland areas interspersed with crumbling side walls and a lot of rocks in the streambed itself. These rocks wash down the stream during flood events causing considerable damage lower down.

Figure 8: Above Left to Right: 1 and 2: small patches of wetlands along the water course above the abstraction point and 3 and

4, eroding side walls which are very unstable in some sections.

- Rehabilitation efforts are to focus upstream of the abstraction points and specifically around the small wetland patches that are still intact or only partially degraded. There are a lot of rocks in the streambeds themselves that can be used to create a cascade of small weirs all long the stream to slow the water down. This is the 1st priority.

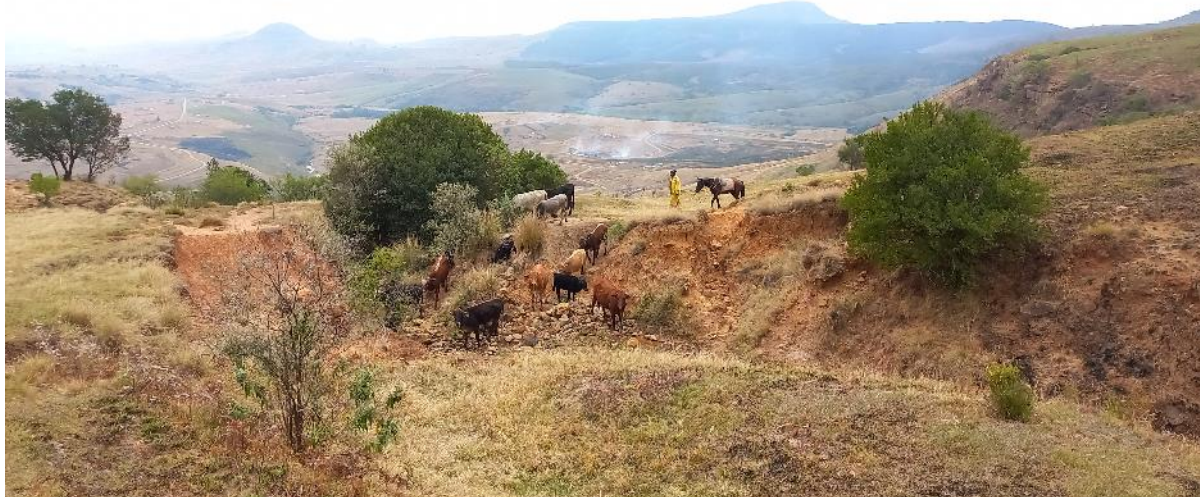
Figure 9: Above: A view of cattle being herded across one of the many small water courses in the upper catchment. There are a number of these tracks - which increases the erosion along the water courses.

- The livestock committee and livestock owners need to be brought properly on board. Here also the interplay between livestock owners from other villages needs to be explored. A workshop going through how this area is managed, who is allowed to do what, how many livestock there are and issues and concerns needs to be undertaken to take the first steps in designing a management strategy.
