# Implementation of Small Community Owned Water Access Schemes

## Vimbukhalo Village

August 2022

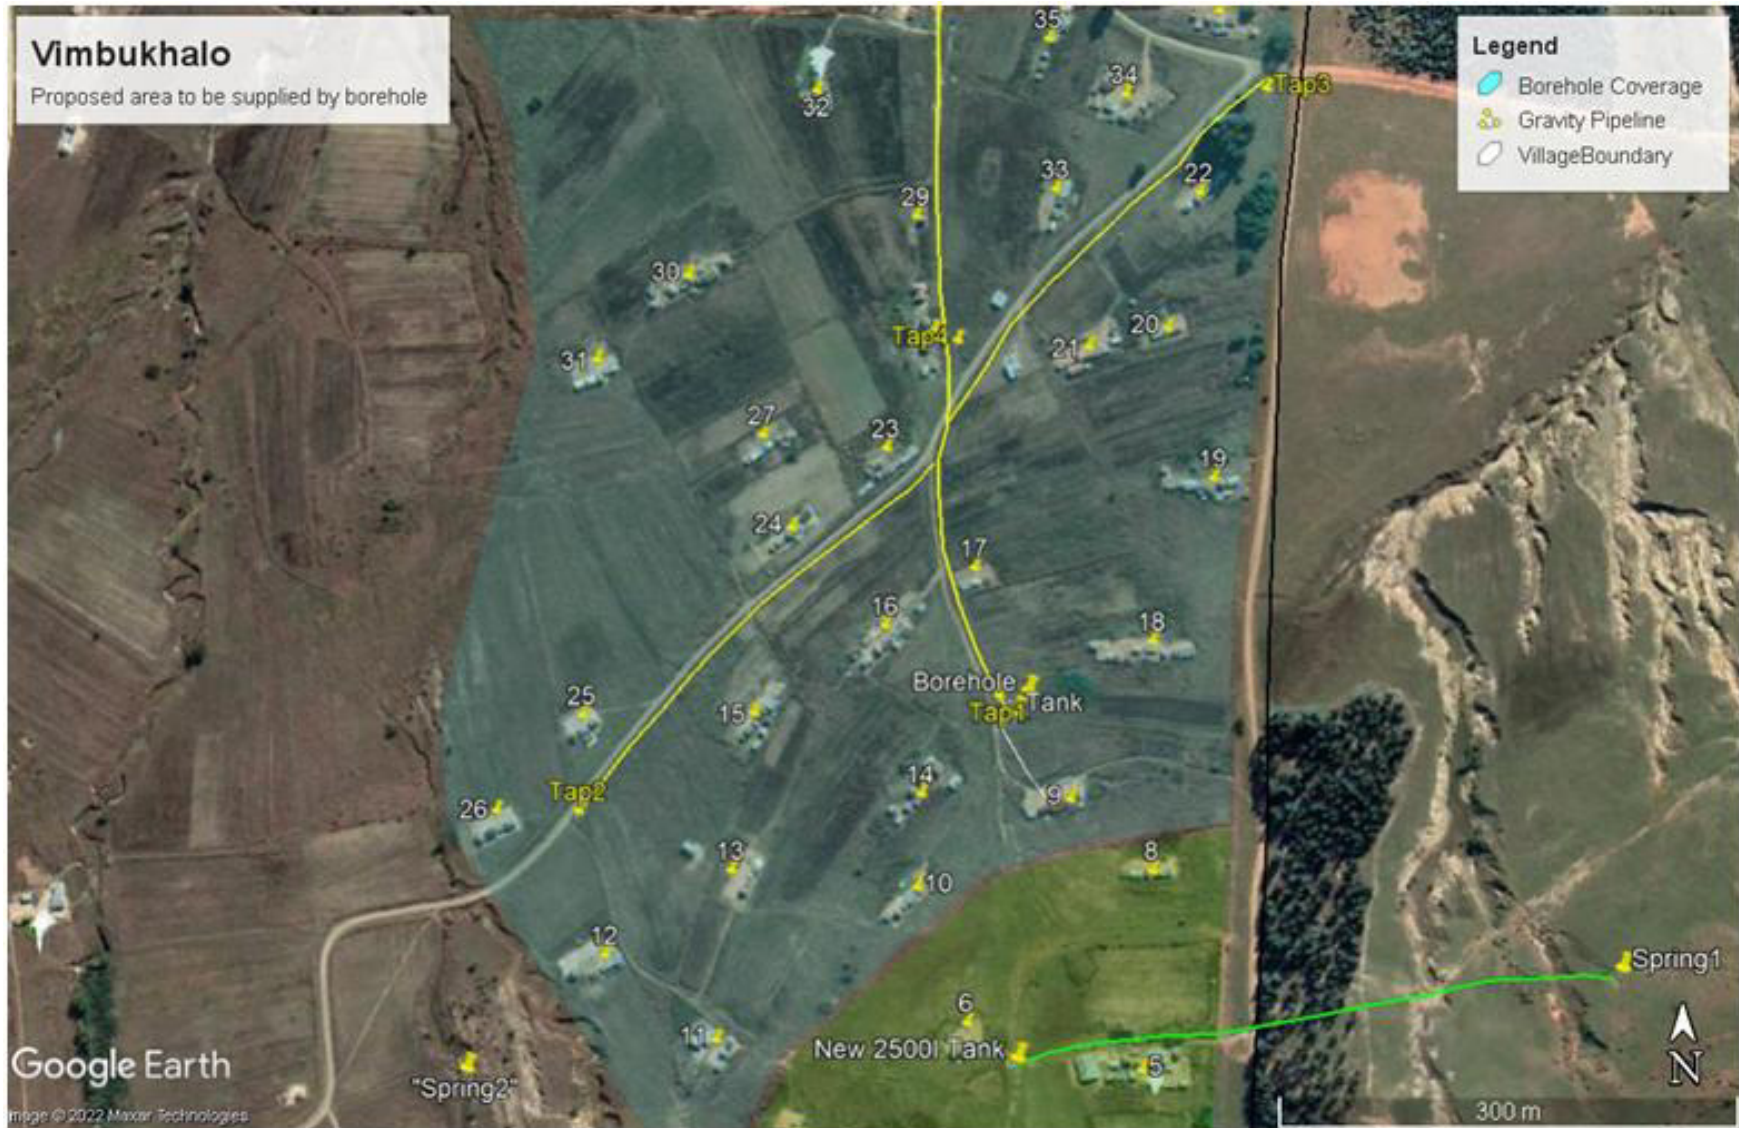
Fig 20: Example layout of borehole supply to village standpipes(map 1 of 2)

Currently there is only one tap installed near the elevated storage tank. Part of the communities request for assistance was for extending the supply to additional access points around the village. This should be possible for village sections that lie below the tank position. One possible reticulation layout and coverage from the borehole has been shown in figures 20 and 21. This has been worked out based on the following assumptions and calculations:

- the borehole yield is not less than the estimated 1000 litres per hour
- communal standpipes and not yard connections are provided
- it is possible for the pipeline to cross the gravel road running through the village
- usage of 25 litres per capita per day and average of 8 members per household (200 litres per household per day). The guideline for yard taps is more at 55 l/c/day)
- storage capacity of 10 000l
- borehole pumping 10 hours per day
- maximum walking distance to standpipe (+-250m)
- number of standpipes = 6
- total households served = +-50

This layout is provided as a starting point for discussions with the community around the type and extent of the supply, and it is anticipated that revisions to the layout and position of taps etc will be necessary. If yard connections (taps or drums) are preferred then coverage would need to be reduced and/or a system of water rationing implemented.
